## MSG 052 (15-0430) - CREW OVERVIEW PACKAGE – OMS POD BLANKET REPAIR

# LEFT OMS POD BLANKET DAMAGE NOMENCLATURE

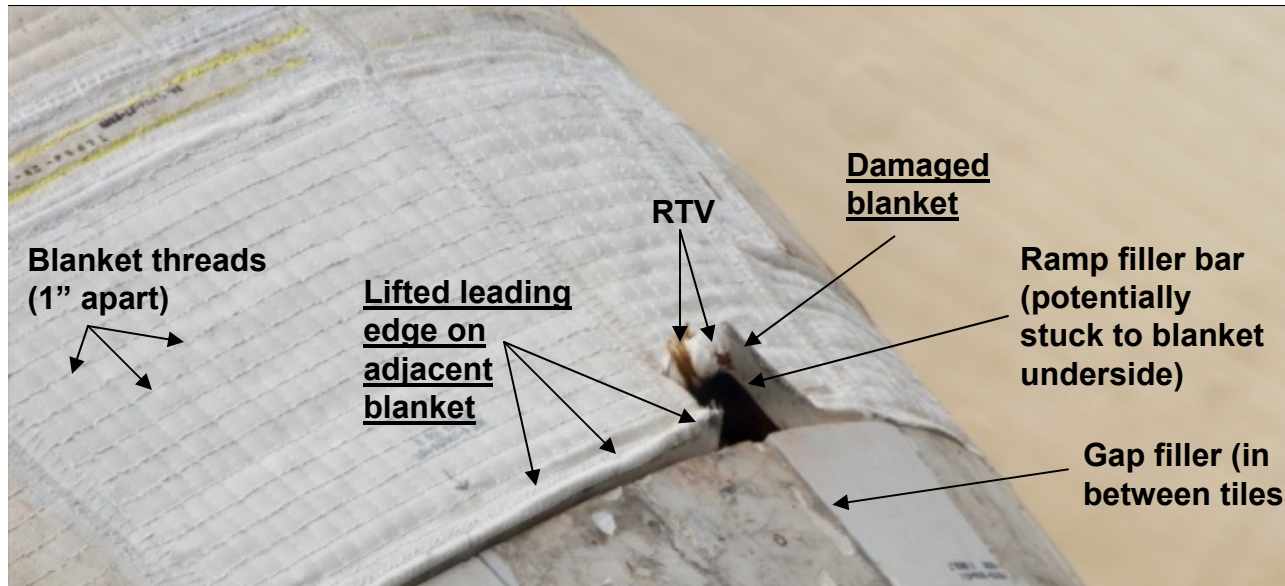
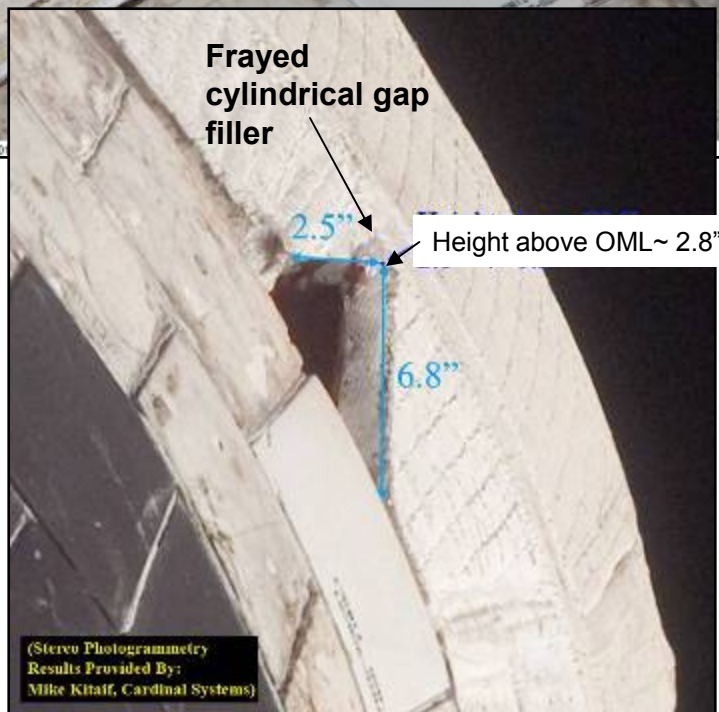
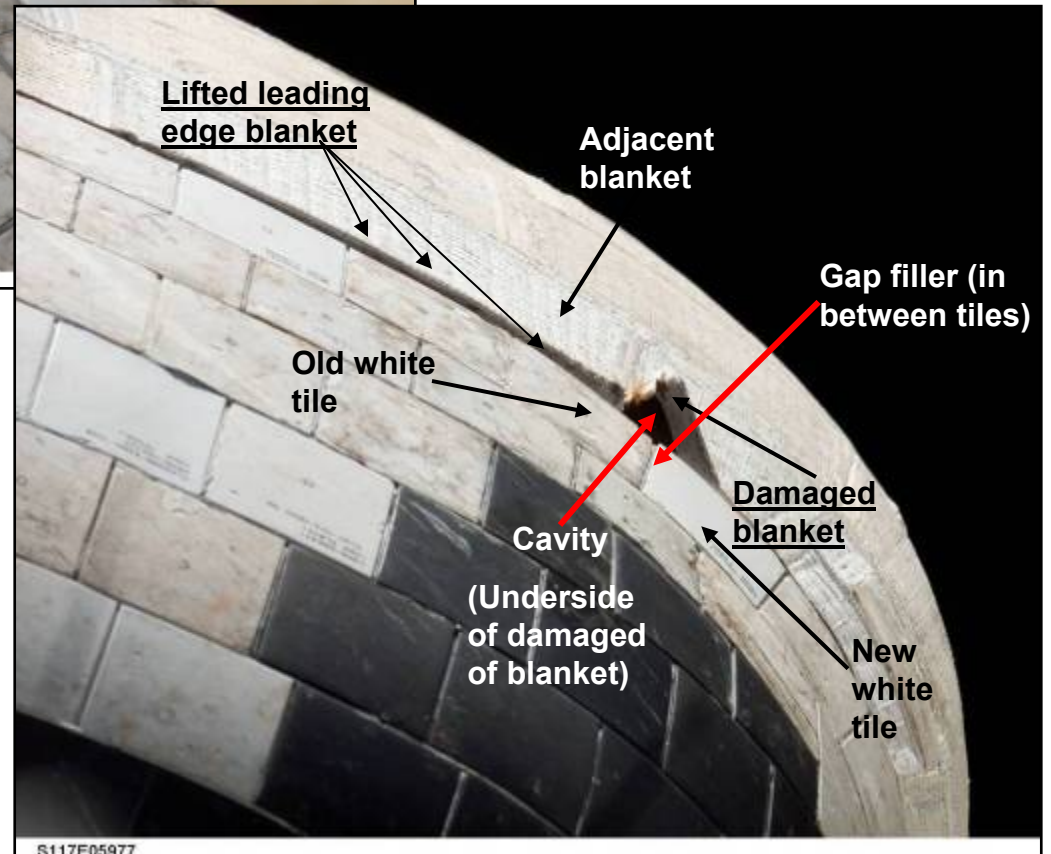
As you know, a corner of an AFRSI blanket has partially lifted from the IML on the left OMS Pod. In addition, the adjacent blanket to the left of the damaged blanket has partially lifted along the leading edge of the white tile. We have excellent photos on the ground that have helped us to fully understand the damaged areas, and as a result have built detailed mockups of the blankets and tile to aid us in designing a workable plan to fix it.

1. Patting down the lifted leading edge on the adjacent blanket (use gloved hand or TPS scraper)
2. Patting down the damaged blanket (use gloved hand or TPS scraper)
3. Stapling damaged blanket to adjacent blanket using IV medical stapler
4. Pinning the adjacent blanket to white tiles using Tile Overlay NiC pins (to be called tile pins and retention pins)
5. Pinning the damaged blanket to white tiles using Tile Overlay NiC pins
6. Taking very specific photo closeouts and WVS scans of the repaired worksite

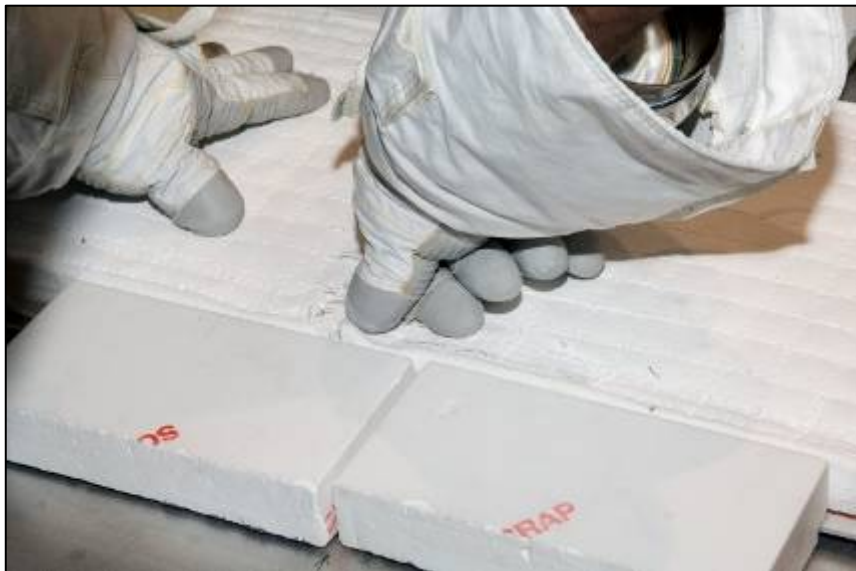
Pat down lifted blanket with hand

1. Use gloved hand to pat lifted leading edge on adjacent blanket down flush or sub-flush to tile OML (TPS scraper can also be used)
2. Memory in blankets should hold them in place after initial pat-down
3. After patting down damaged blanket and stapling, retrieve tile pins from pin caddy as required (do not need to tether to pins):
  - A. Install 6 tile pins (black in picture) from leading edge blanket into white tile (2 pins per tile)
  - B. Pin should enter tile roughly  $\frac{1}{4}$ " below tile OML
  - C. Insert pin into blanket aft of first row of threads; push pin through blanket and tile until just pin loop is visible
  - D. Install retention pins (red in picture) through 6 original pin loops (through loop hole from right to left to tack down original pins)
  - E. Slightly bend pin loops down so that they lay as flat as possible

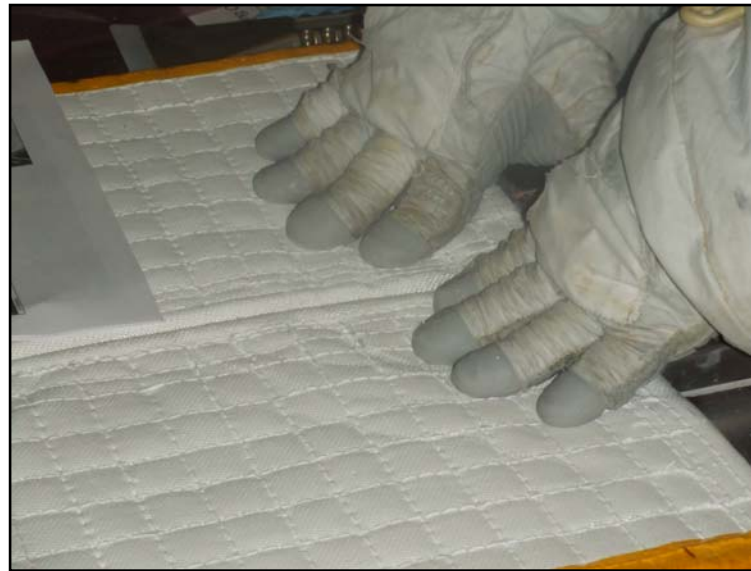
Pat down lifted blanket with hand

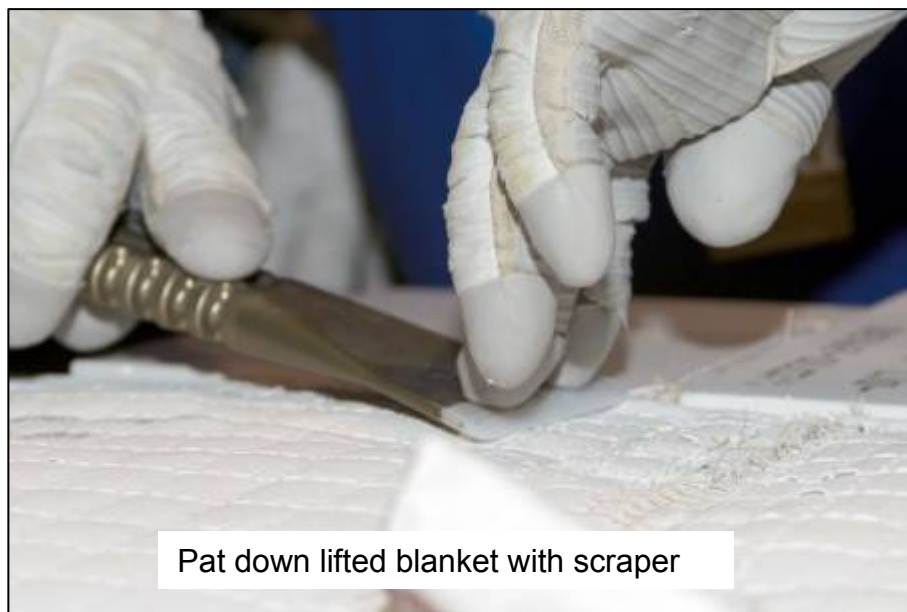
Pat down lifted blanket with scraper

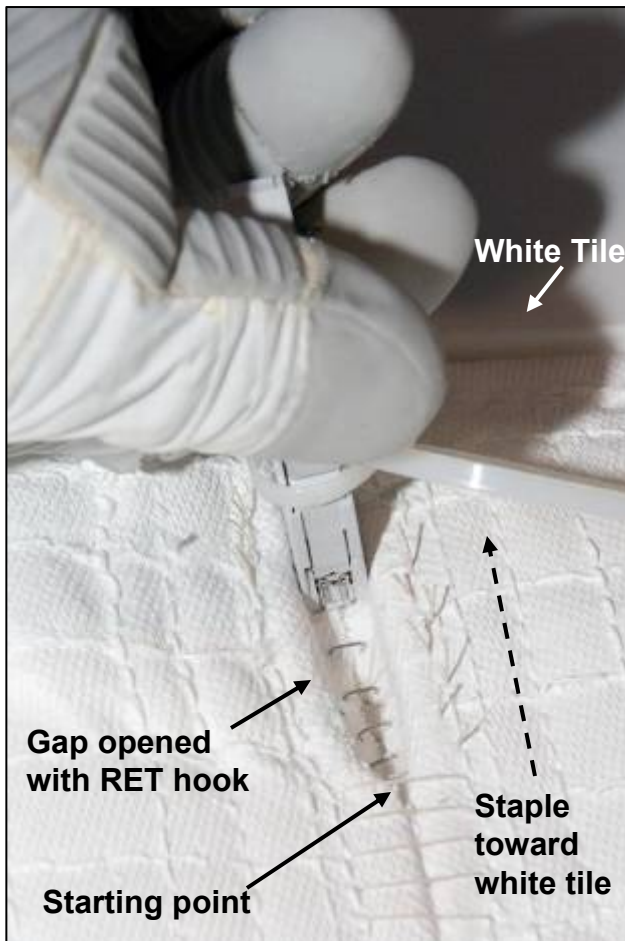
Inserting lower row of staples

2. Use stapler to attach damaged AFRSI blanket to adjacent blanket.
  - Attempt a lower row of staples near IML, massage blankets to close the gap, and then add an upper row of staples at the OML
  - Start stapling away from tile, and then work toward tile
  - Utilize ~ 3 staples per inch (2 staples in between threads, and 1 staple in line with each thread)
  - --- stitching rows on blankets are ~ 1 inch apart thread to thread
  - There should be a minimum of 8 lower staples and 10 upper staples
  - **WARNING**: If a staple becomes stuck in the glove, do **NOT** attempt to remove the staple; the idea is that it will seal the bladder
  - **OPS CONSTRAINT**: Keep staples at least 1 inch away from fingers
  - **OPS CONSTRAINT**: If a staple is not fully stuck in a blanket, do not attempt to remove

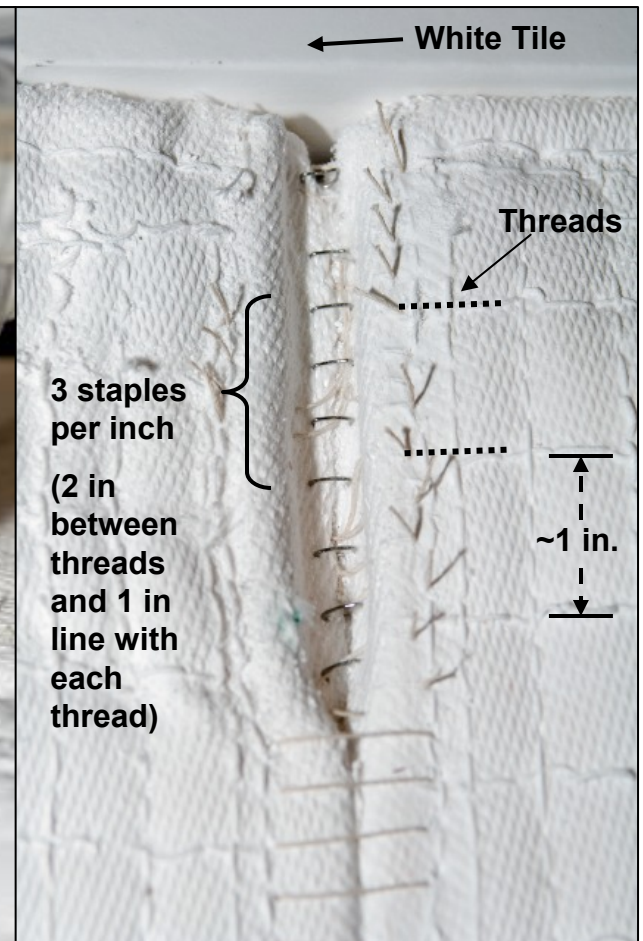
Lower row of staples

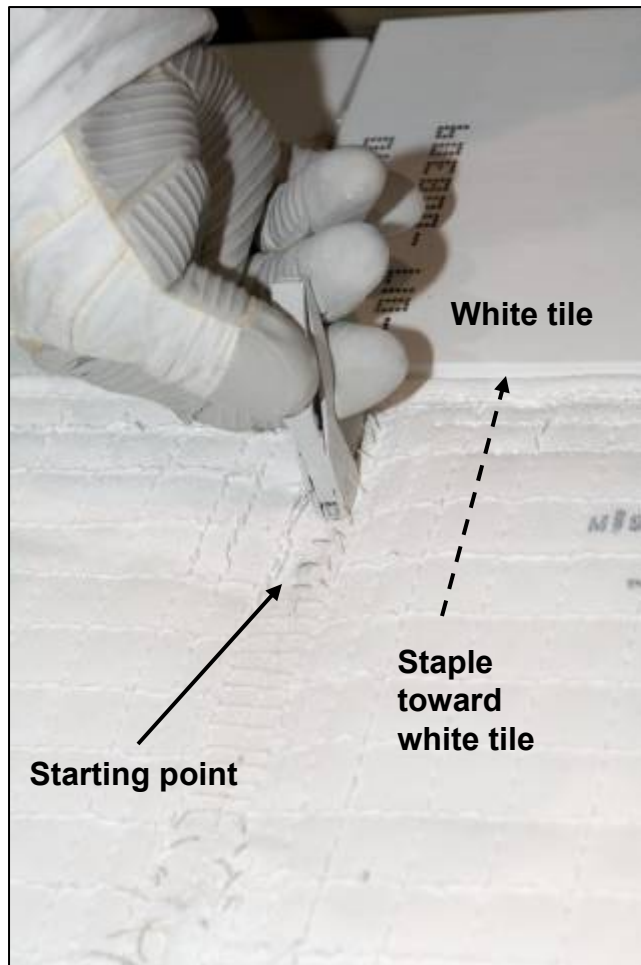
Inserting upper row of staples

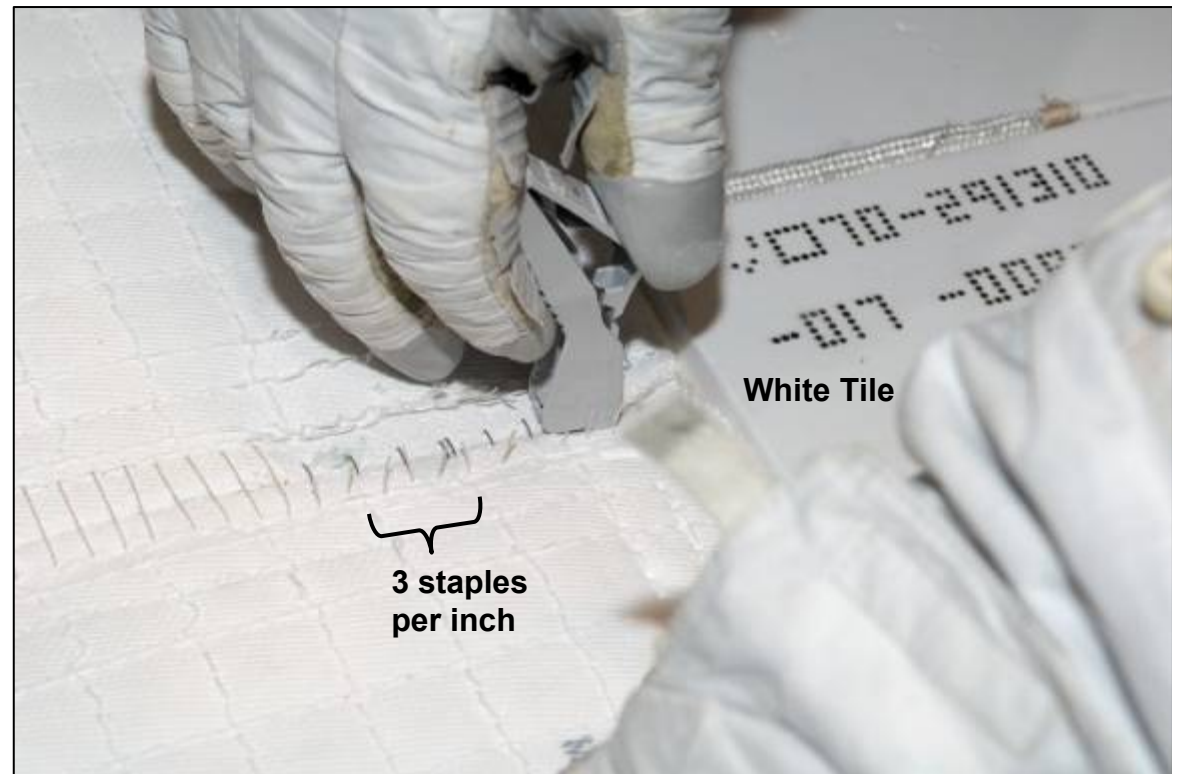
Upper row of staples

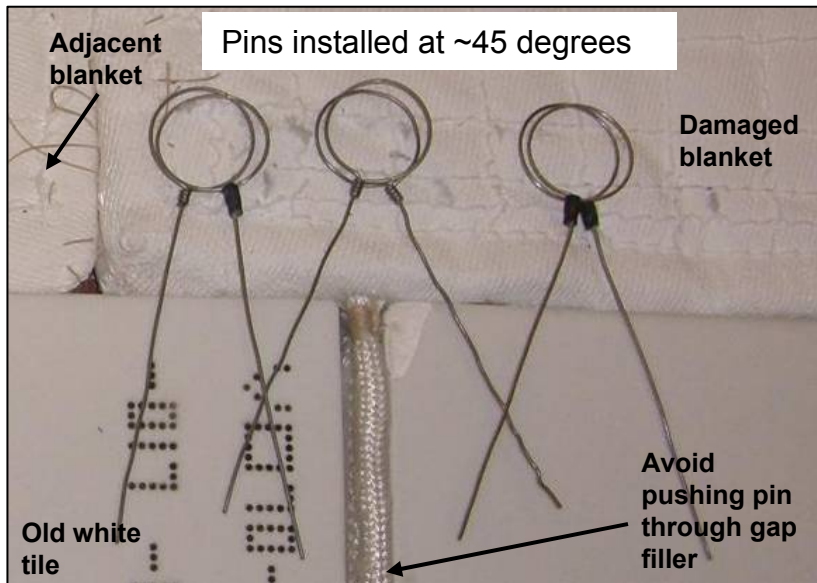
Tile Pins Shown (6); not installed yet

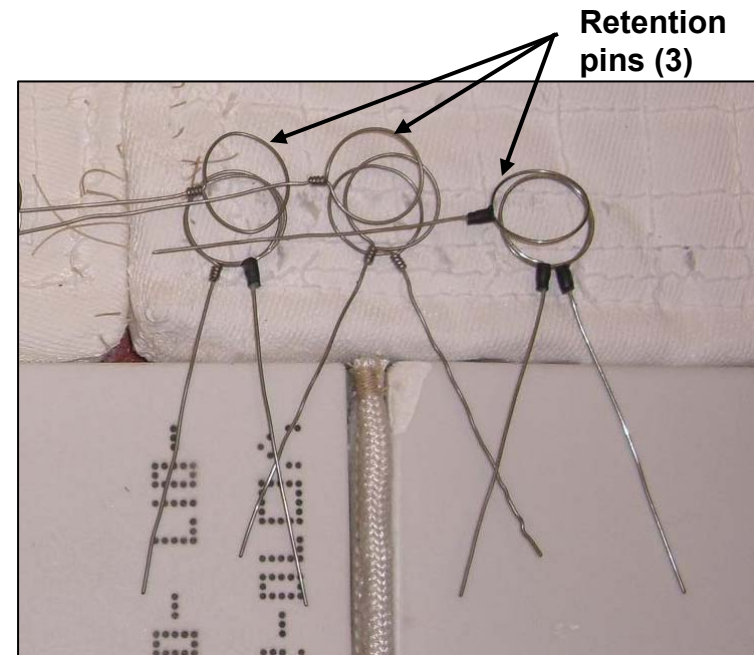
Retention Pins (3) shown with Tile Pins (6); not installed yet

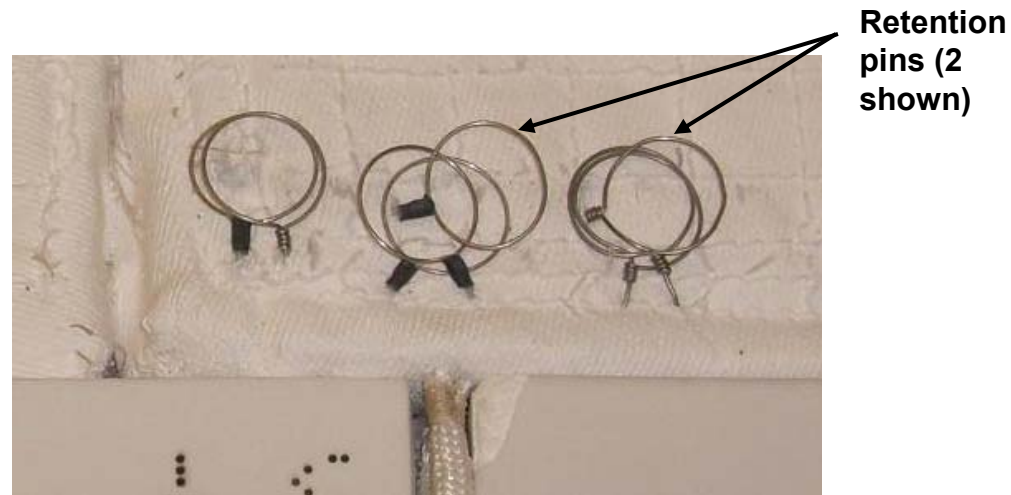
Tile Pins (6) Installed In Tile with Retention Pins Installed (2 of 3 shown)
